Rehabilitation of pipelines, an evaluation method with application to 3 trenchless technologies

J. van Vossen (KWR, NL), G.A.M. Mesman (KWR, NL), T. van den Brand (KWR, NL), J. Henzen (Heijmans, NL), M. Nooijen (BAM, NL), M. v.d. Wijst (BAM, NL), H. Vogelaar (WML, NL), R.F van Nieuwenhuijze (Brabant Water, NL), B. Jacobs (Vitens, NL)

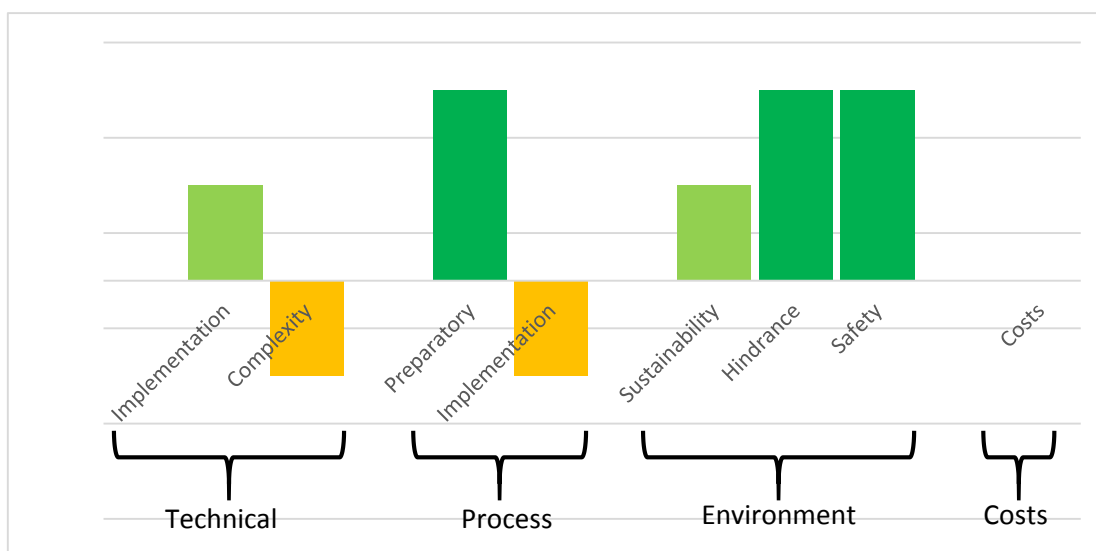
Figure 2 Example of effect diagram, with red indicating the technique performs poor compared to a traditional open-cut approach, orange (moderate), yellow (equivalent), light green (reasonable) and dark green (much better).

The experiences with individual pilots have shown that for a single pilot location a rating of environmental aspects and costs leads to unwanted results, because these elements are very much locally determined. Therefore, individual pilot locations were rated only for technical and process related aspects and analyzed, but not rated for environmental aspects and costs. The full rating is therefore only possible when evaluating several projects at once or for scenario calculations. The full rating is presented in an effect-diagram, with different colors representing performance. An example is shown in Figure 2.

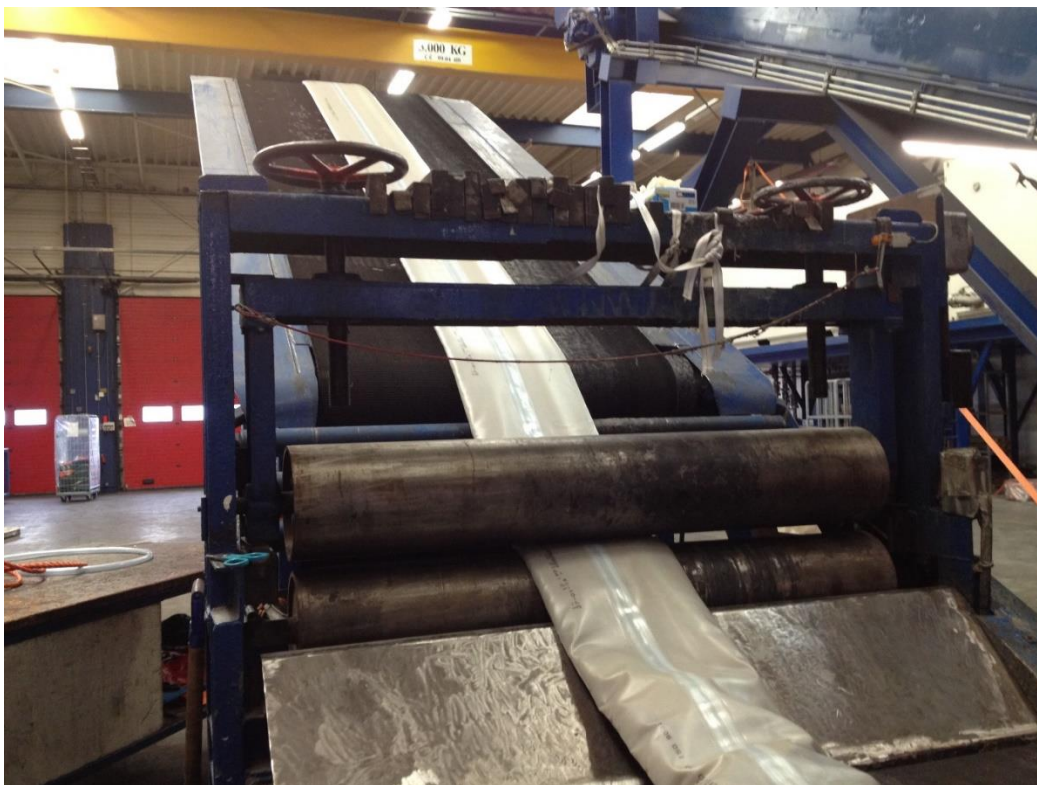
Figure 1 Impregnating a liner with resin.

This is a Cured in Place Pipe (CIPP) in which a resin impregnated liner (Figure 3) is pulled into a pipe after which the liner is cured using high temperatures that initiate and maintain a chemical reaction turning the liner and resin into a fully constructive new pipe. This type of trenchless technology is quite common in sewers since decades, but until recent no Dutch certified technology was available for drinking water. To obtain the required certification a new resin was developed that does not impact the drinking water quality and still maintains the required characteristics to ensure a strong liner.

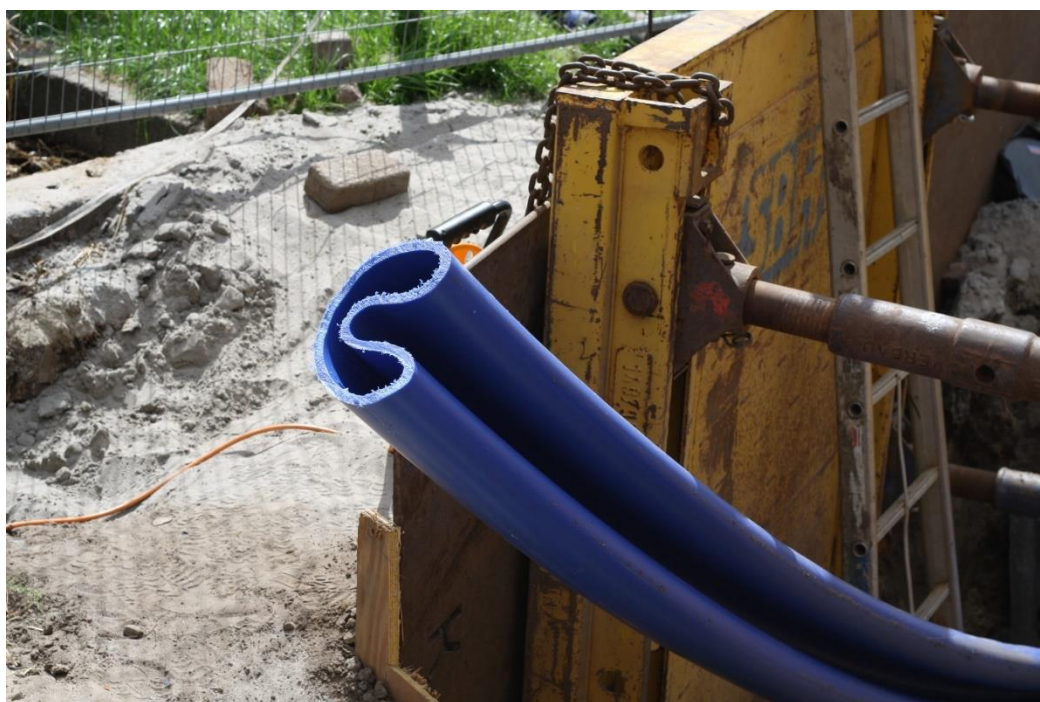
Figure 2 Application of Compact Pipe in Zwaagwesteinde, Friesland.

This is a close-fit technique in which a fully constructive, pre-folded PE-liner is pulled through an existing pipe and then reshaped back into its original shape. This technique was applied to a 300 mm CI pipe in Zwaagwesteinde (June 2016, Figure

4) (<http://nl.wavin.com/web/oplossingen/drinkwater/hoofdnetwerk/close-fit-lining-compact-pipe-3.htm>). The pipe is a bitumen coated CI pipe to ensure continuous supply in situations with increased demand or problems with the regular supply route. The water in this specific pipe remains still for extended periods of time. During these periods PAH's were released from the bitumen coating. To ensure water quality the pipe needs extensive flushing before operational use. The Compact Pipe should resolve this problem. A specific research question in this pilot concerned whether the permeable PE liner would sufficiently reduce the water quality problem.
